FIELD INSPECTION

Project Name:	Mountain Valley Pipeline	Inspector:	Matthew Grant
Inspection Date:	Tuesday, January 21, 2020	Project Contact:	Brian Clauto
Spread: Roanoke Co. MP 239.9- 240.4 MP239.1-239.4 MP 240.4 ATWS: 955, 955A, 1225, 1224, 968, 1329 AR RO 279.01	Spread H	Weather (Wet/Dry/Rain):	Dry

FIELD INSPECTION PHOTO LOG

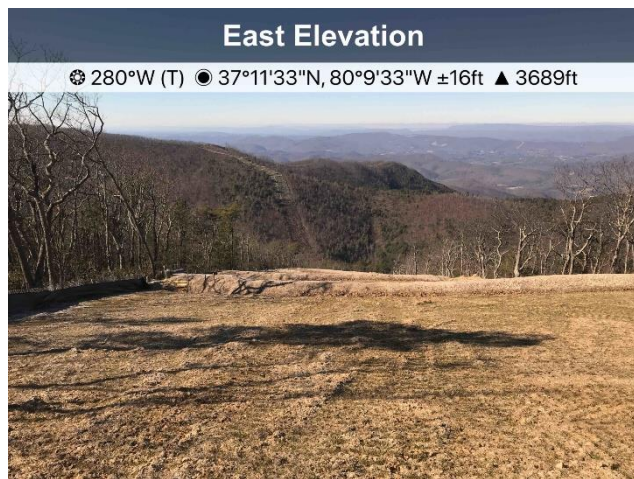
- Fig. 1. Near MP 239.9, area is stabilized and ECD's are in place.

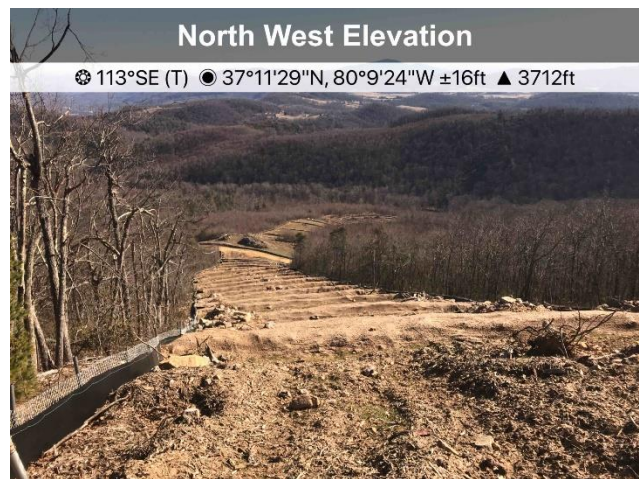
- Fig. 2. Near MP 240.2 area is stabilized and ECD's are in place.

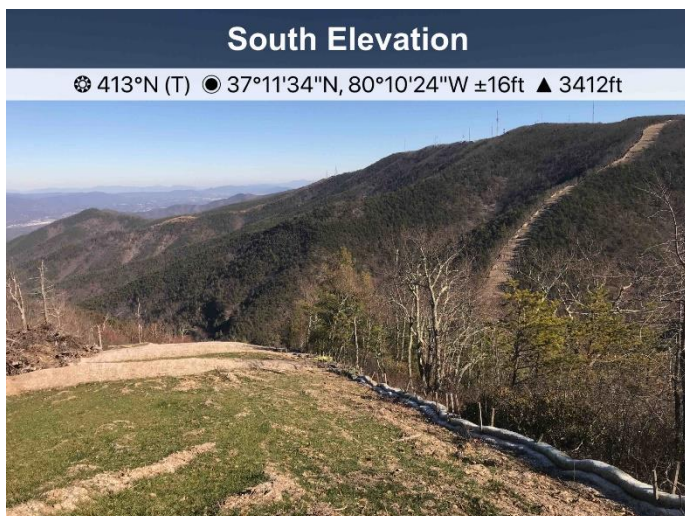
- Fig. 3. Near MP 239.1 area is stabilized and ECD's are in place.

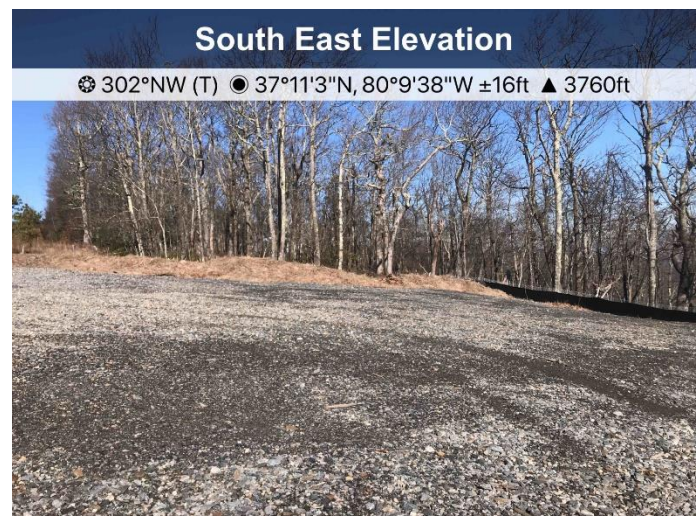
- Fig. 4. ATWS1225 is currently not being used, ECD's are still in place.
